# Physical and Chemical Assessment of Streams in the sub-Andean Amazon, Peru

### **Physical and Chemical Assessment of Streams in the sub-Andean Amazon, Peru**

Keyword: Peru, Amazonas, sub-Andes, rainforest, water quality, water assessment, deforestation, physical assessment, stream reach assessment, SVAP, drainage area, GIS

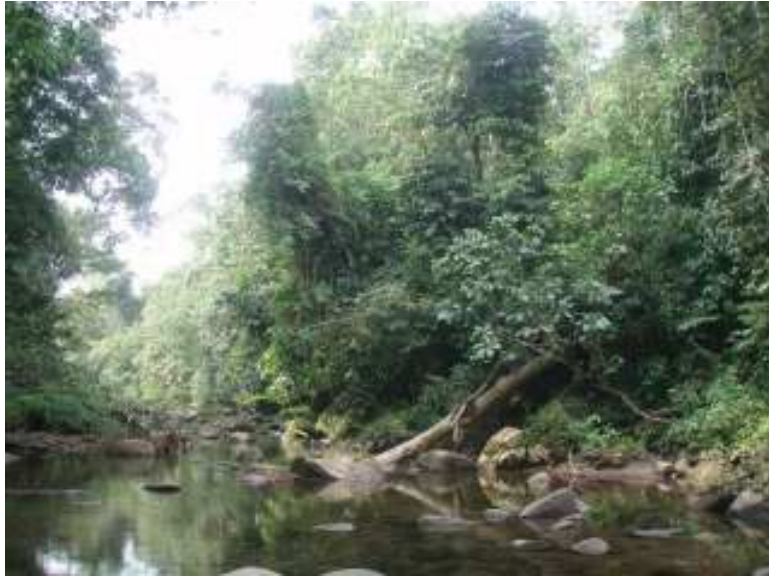
**Figure 3** Riparian zone on both sides of the Shima River, Peru  
(Photo: Lindgren & Röttorp, 2007).

The riparian zone functions as a buffer zone which regulates the flow of many elements between surrounding land and the stream water. For example, trees and plants in the riparian zone can reduce the water velocity and increase the travel paths of the water. It can therefore result in deposits of sediment and attached nutrients. In addition, dissolved nutrients can be adsorbed by organic material and the mineral soil or be taken up by plants (Brady & Weil, 2002). Other elements, such as metals and contaminants can also be adsorbed or/and be taken up by plants in a similar way. Furthermore the vegetation zone helps to stabilize the stream banks by protecting the soil surface from impacts such as heavy rainfall and thereby decrease the risk of heavy erosion (Buffler, 2005) and partly by its soil holding capacity where the roots help to bind the soil (Brady & Weil, 2002; Buffler, 2005). The zone also provides habitat for stream biota, fish and terrestrial insects and shade of the water surface which reduces water temperatures and offers protection of aquatic water organisms by increasing the oxygen holding capacity of the water. Last, but not least, it provides organic material for stream biota (SVAP, 1998). The optimal design of a riparian zone is one that is densely vegetated and not overly trampled. That is how it should be built up to function at its best and be an effective buffer in order to decrease the amount of elements from reaching the stream water and thereby protect the stream health. Furthermore it should also have a width of six to sixty metres, although ten metres is usually sufficient to obtain most of the removing benefits (Brady et al., 1999). Many earlier studies have stated that the width is the most important variable in determining the effectiveness of the buffer to control the flow of contaminants into the streams (Buffler, 2005; Stream Visual Assessment Protocol, 1998). The land use adjacent to the riparian zone can easily affect the function of the zone and therefore it is important that the land use is carefully managed (Brady & Weil, 2002). Figure 3 shows an example of a riparian zone on both sides of a stream.

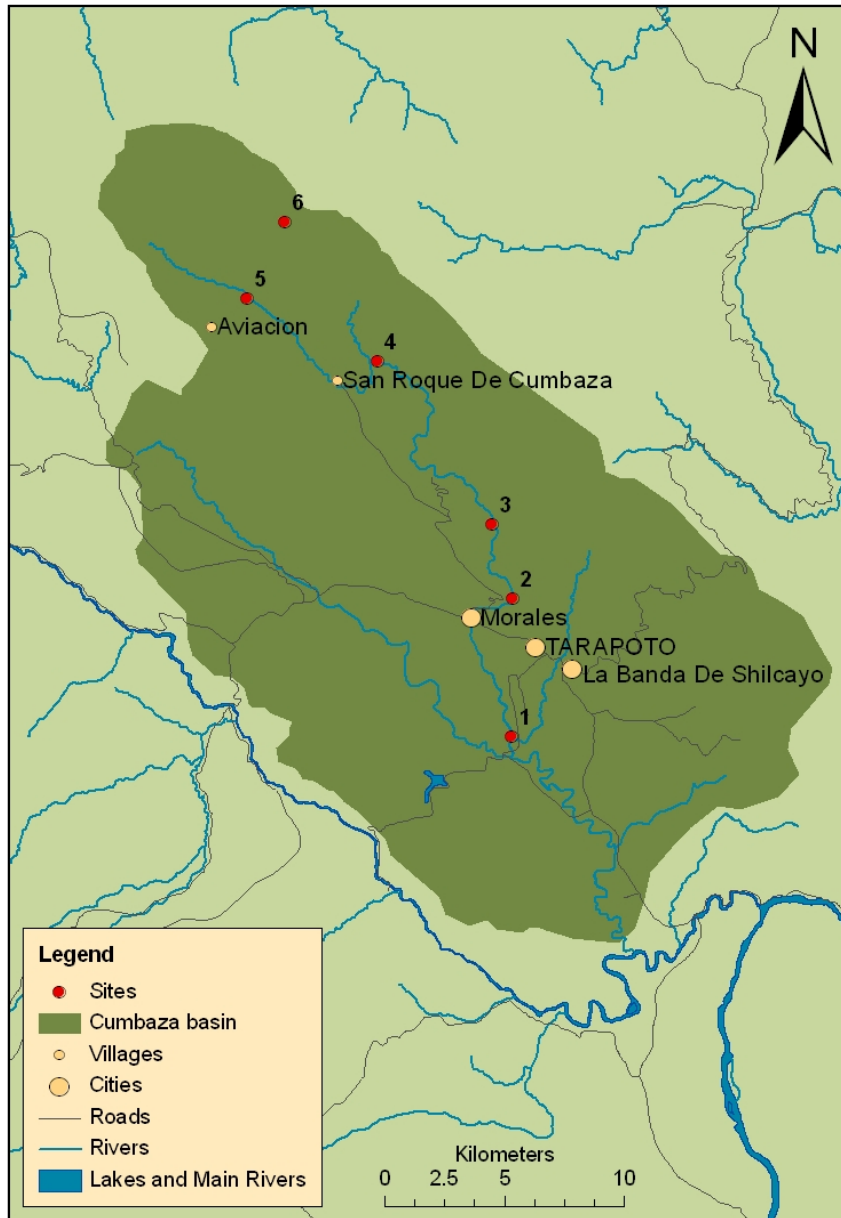
**Figure 7** Map showing the sites in the Cumbaza basin. Only the cities and villages mentioned in the text are shown on the map.

The site furthest downstream (called C1) is situated just south of Tarapoto, close to the airport. Five more sites were selected upstream in the river. The sites C1-C3 are all located close to Tarapoto and they are easy to reach by car. People visit these places every day, especially C1 where a road crosses the river (in the water) about 10 metres downstream from the site. Sites C4-C6 are located in a more remote area. This area is characterized by small-scale farmlands. C4 and C5 are frequently visited but by far less people than the sites further downstream. The areas around C6 and partly around C5 are part of the conservation area Cordillera Escalera (Cedisa, 2006). Figure 7 shows the location of the sites and in Table 4 a summary of the description of the sites along the Cumbaza River is given. The description of the riparian zone, water and land use gives an idea of the appearance of each site. The coordinates of the sampling sites are found in Appendix 4.

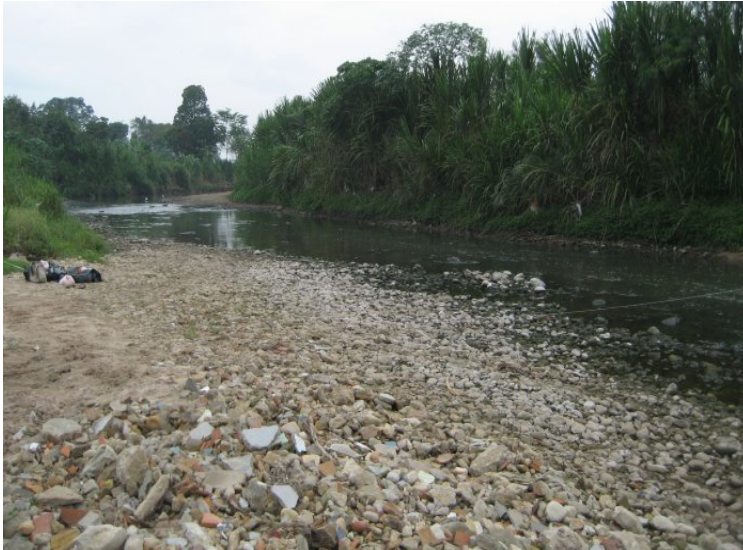
**Figure 8** The site C1, looking downstream (Photo: Lindgren & Röttorp).

*Site C1:* Located downstream from Tarapoto and the airport. A lot of pollution is washed down into the river from the city. A road passes through the river. There is no or little forest and the vegetation on the banks is lower than at the other sites, consisting mainly of bushes and grass, see Figure 8. The water is used only for car washing. People collect sediment from the river bottom to add to concrete. Figure 8 shows a photo of site C1.

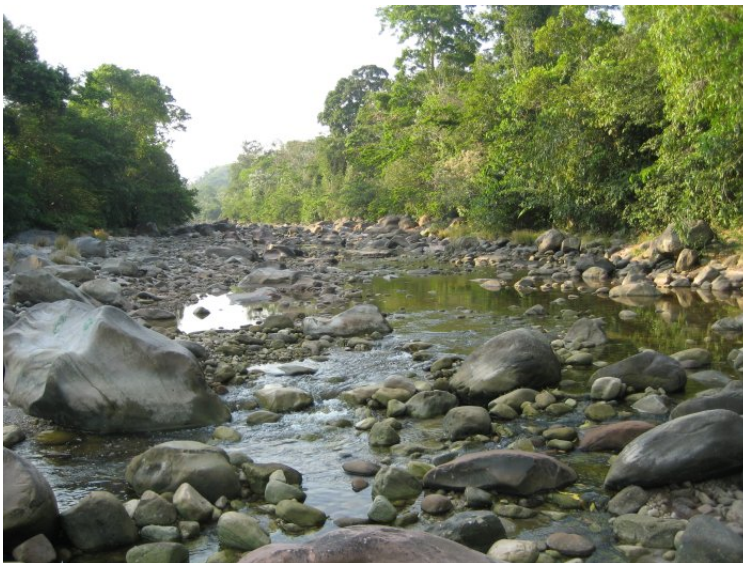
**Figure 9** A short distance upstream site C2 (Photo: Lindgren & Röttorp).

*Site C2:* Buildings are located close to the river. There are farmlands, both large and small, close to the river. People pass here or in the close surroundings everyday and a road reaches all the way down to the stream. The water is used both for bathing and washing. Only secondary vegetation is found here and it is less dense than upstream, see Figure 9. Still the riparian zone is quite intact.

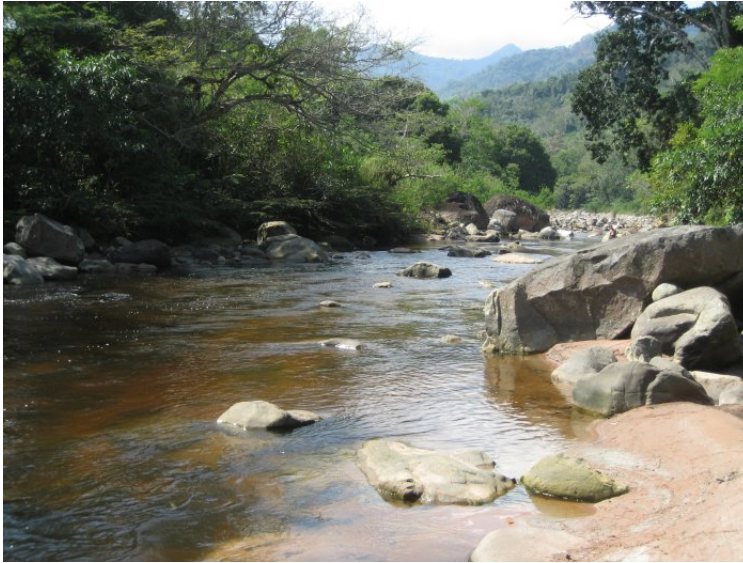
**Figure 10** Site C3, looking upstream (Photo: Lindgren & Röttorp).

*Site C3:* This site is a popular recreation spot but the water is also used for washing and as drinking water. There are large farmlands in this area and the vegetation around the river is mostly secondary forest, see Figure 10. A big rice plantation receives water from the river upstream through a canal.

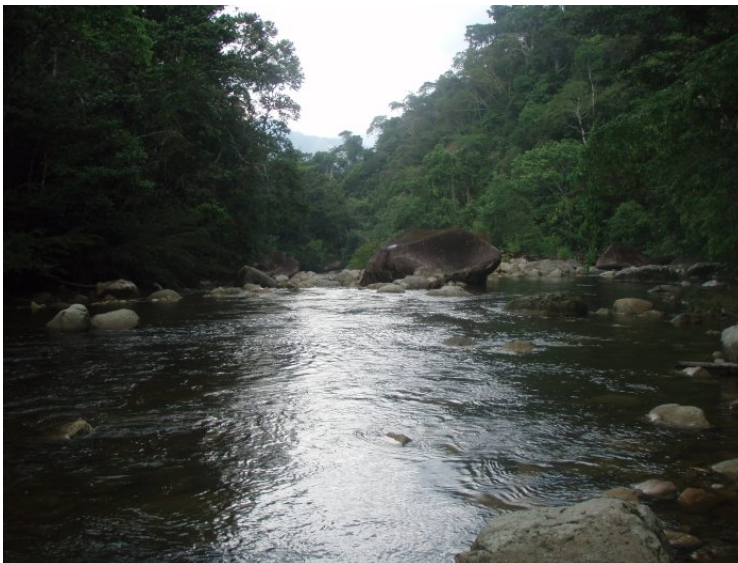
**Figure 11** Site C4, looking downstream (Photo: Lindgren & Röttorp).

*Site C4:* This site is located in the hilly area, about one kilometre downstream from the village San Roque de Cumbaza in an area that is partly protected. The forest contains primary forest but also secondary - especially a bit upstream where some deforestation occurs. Tourists regularly visit this area but overall only a few find their way here. There are a few small cultivations close to this site but not adjacent to the riparian zone (Figure 11). The water is used mostly upstream from this site, closer to San Roque.

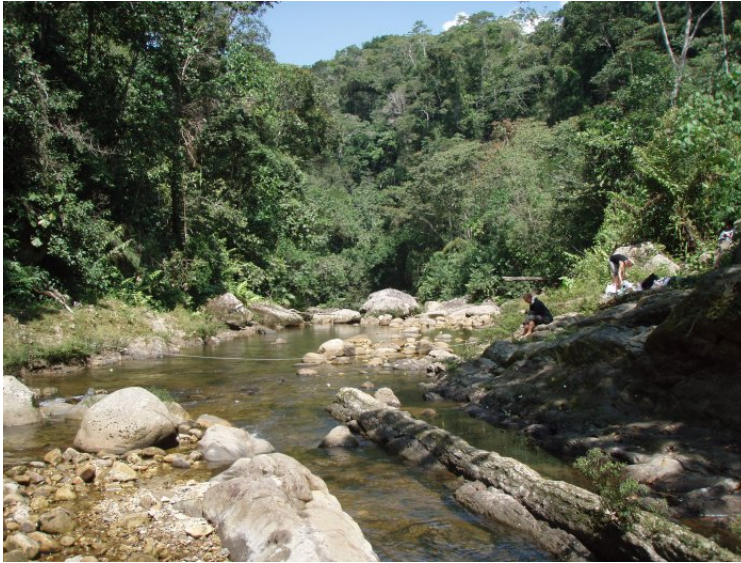
**Figure 12** Site C5 (Photo: Vasques).

*Site C5:* This site is situated close to the village of Aviación with farmlands along one side, but not seen from the site (Figure 12). A path is also passing through the river why people and animals cross the river here several times a day. There is also a *tambo* (see footnote 24) close to the river where people rest and cook. The water from the stream at this location is used for water supply; washing etc. The stream is surrounded by mostly primary but also secondary forest.

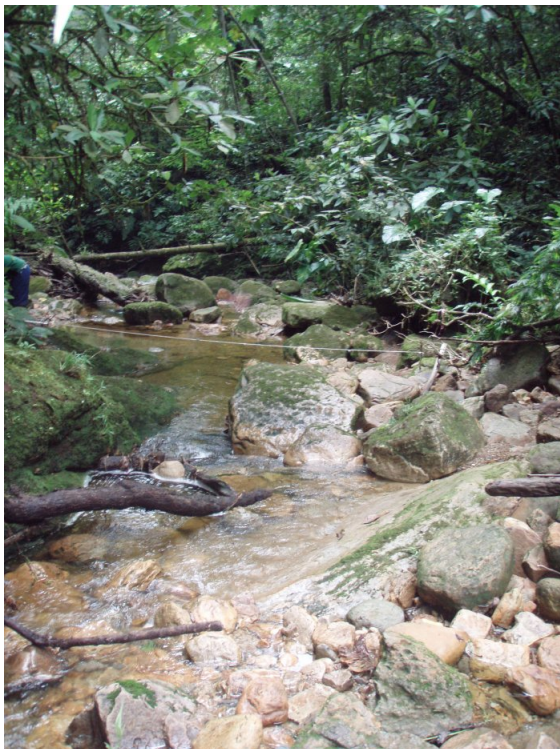
**Figure 13** Site C6 (Photo: Lindgren & Röttorp).

*Site C6:* This site is situated in an area with primary forest (Figure 13). There are no cultivations or other human activities found in the adjacent areas. There is little human activity in this area, though the interest from tourists to visit the primary forest and a famous waterfall a bit downstream is increasing.

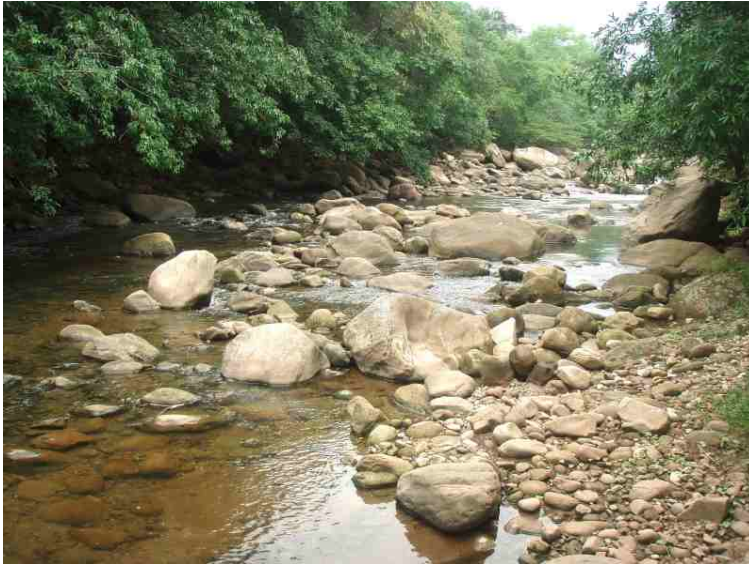
**Figure 15** Site S1 (Photo: Lindgren & Röttorp, 2007).

*Site S1:* This site is situated close to a banana field and an enclosed pasture land. The character of the terrain in the surroundings along the stream bank at one side makes this site easily accessible for people but also for animals grazing on the pasture. Activities such as washing and bathing are very common. The vegetation is partly primary.

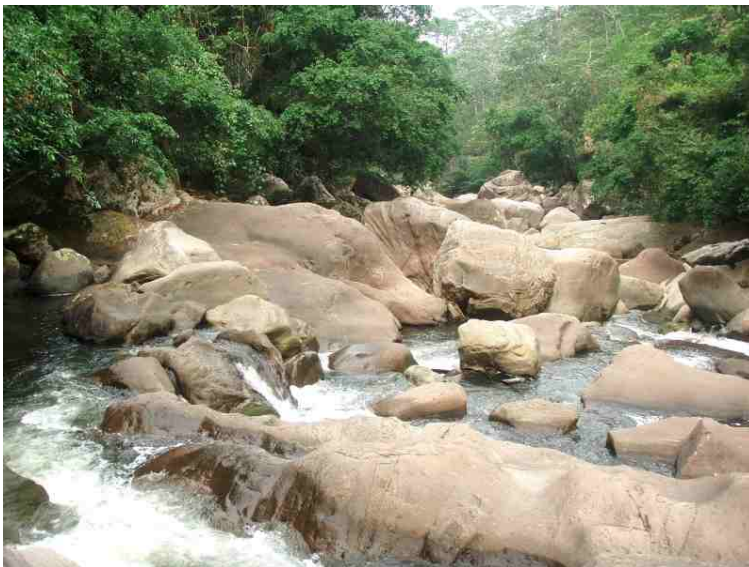
**Figure 16** Site S2 (Photo: Lindgren & Röttorp, 2007).

*Site S2:* A water withdrawal is located 100 metres upstream from this site. Not many people are visiting this site, although the access is quite easy as a path reaches almost right down to it. It is not common for animals to use this path either, even though it cannot be excluded that they do. The vegetation is dense and partly primary.

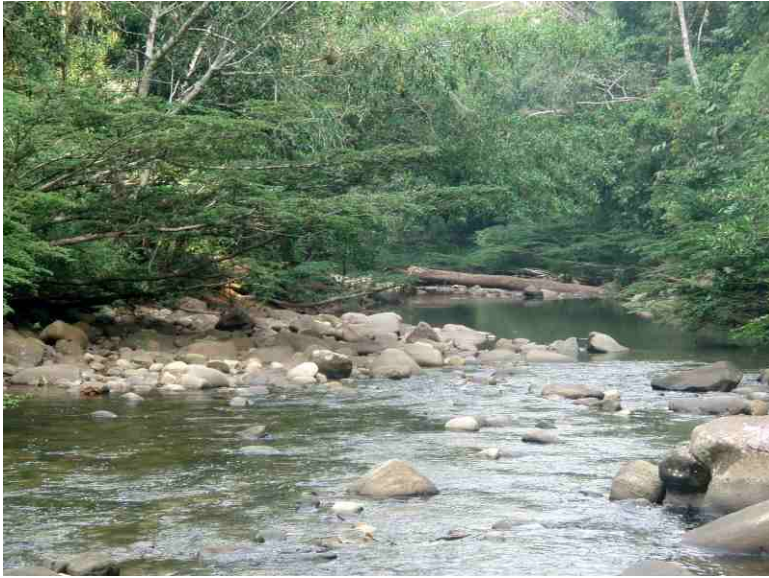
**Figure 17** Site S3 (Photo: Lindgren & Röttorp, 2007).

*Site S3:* This site is situated close to large fields of rice, maize, cacao and bananas. No chemicals are used on these crops. People use the water here for laundry, washing and bathing. The vegetation is partly primary on both sides of the stream but is more fragmented on the left side (looking downstream).

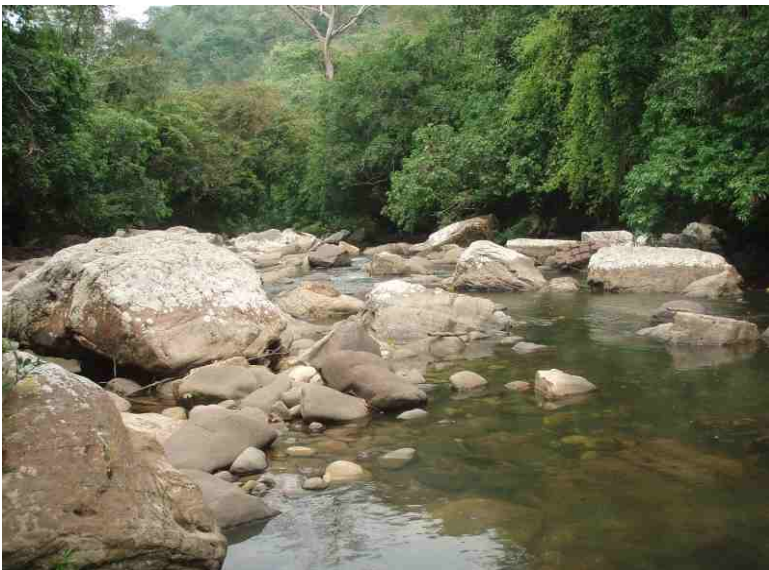
**Figure 18** Site S4 (Photo: Lindgren & Röttorp, 2007).

*Site S4:* A field with rice and/or cacao is situated about 80-100 metres directly above this site. Animals such as horses and cows have access to the stream and people use the water for washing and bathing. The vegetation is mainly secondary.

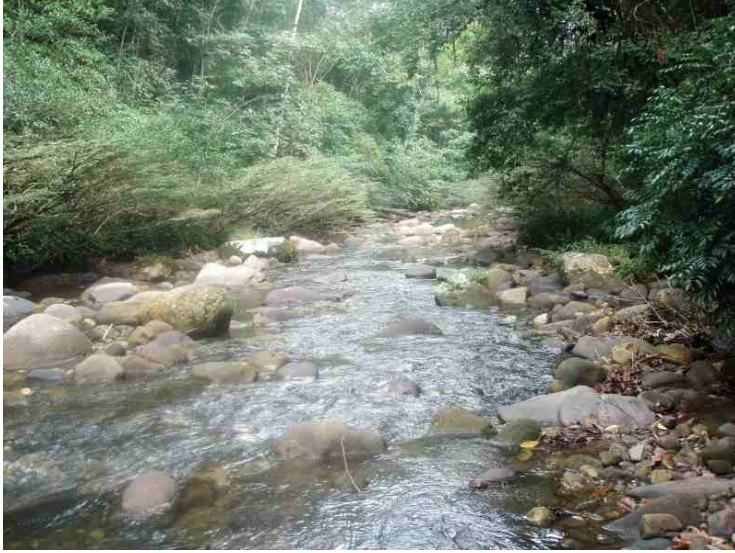
**Figure 19** Site S5 (Photo: Lindgren & Röttorp, 2007).

*Site S5:* A larger cropping field is located about 20 metres just above the riparian zone directly above the site. Very few people visit this site but among those few that do visit bathing can occur. There is no evidence of animals even though it is probable that horses and/or donkeys walk along the path stretching along the field. The vegetation is dense at this site and mostly secondary.

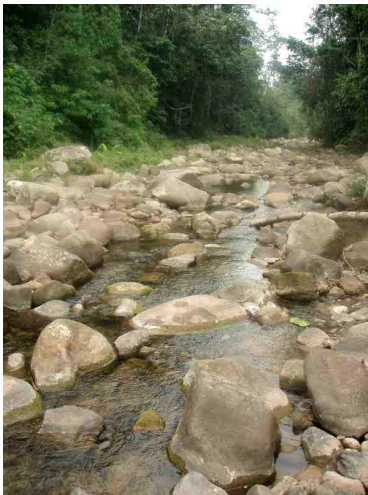
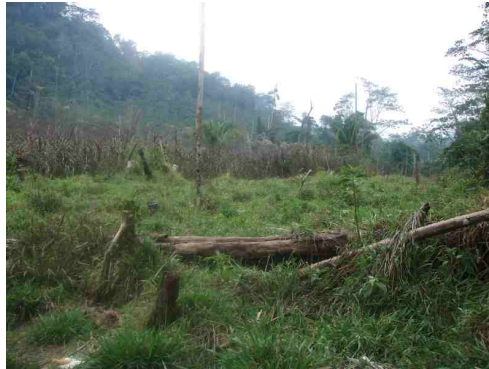
**Figure 20** Site S6. The stream (left) and adjacent slash and burn field (right). (Photo: Lindgren & Röttorp, 2007).

*Site S6:* A slash and burn farming site is situated at a distance of 4-5 metres from the stream. People living nearby use the water for washing (approx. 5 people). A smaller village is located about 100 metres upstream and people there also use the water for washing and bathing. There is evidence of some manure just close to the riverbank which proves that animals may have access to the stream. The vegetation is partly primary.

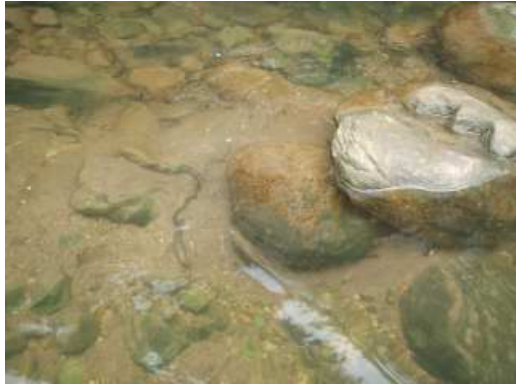
**Figure 26** Stones partly embedded in bottom sediment (Photo: Lindgren & Röttorp, 2007).

Riffles are areas where the water is breaking over rocks or other debris. The degree to which gravel and cobble substrate are surrounded by fine sediment relates directly to the suitability of the stream as a habitat for fish spawning. Figure 26 shows an example where stones are partly embedded in sediment in the Shima River. We graded this parameter through estimation of the percentage of the gravel and cobbles covered with sediment. A percentage distribution was used to assist the estimation (Appendix 3).

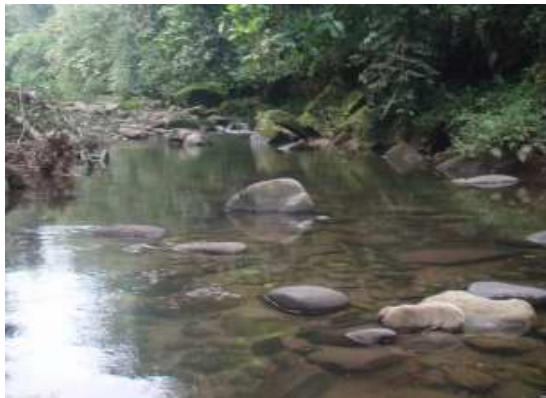
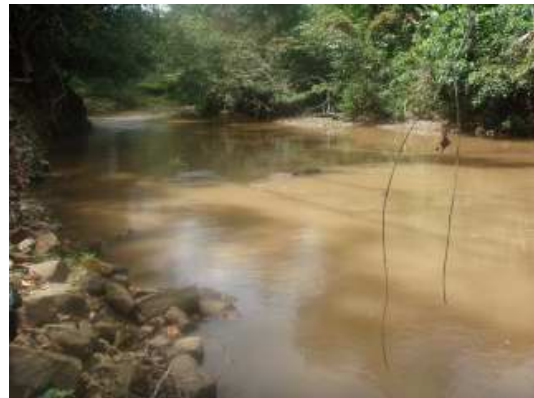
**Figure 27** Water with a clear appearance (left) and water with a great amount of suspended material (right) (Photo: Lindgren & Röttorp, 2007).

This parameter is all about the amount of suspended material in the water. Suspended material in the water causes turbidity which is an indicator of water clarity or the ability of dissolved material to spread and absorb light. Turbulent water allows smaller amount of light to penetrate into the water. This can reduce the photosynthesis among photosynthetic organisms in the water and in turn reduce the amount of oxygen produced by these aquatic organisms. The result could be a lack of oxygen in the water. This parameter was graded visually by investigating how clear the water appeared to be. Pictures from a reference site were used as a comparison. Figure 27 shows examples of waters (from the Shima River) with different appearance.

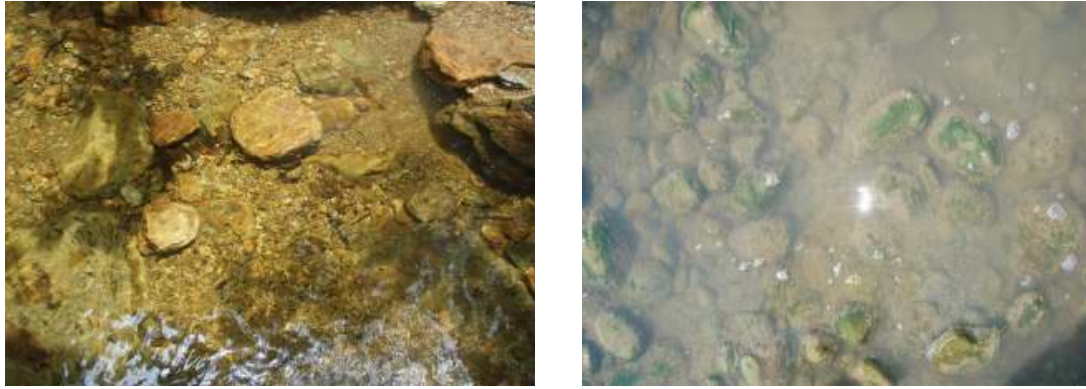
**Figure 28** Stones with a lack of algal growth (left) and stones with a great amount of algal growth (right) (Photo: Lindgren & Röttorp, 2007).

The amount and type of aquatic vegetation in the stream can work as an indicator of the amount of oxygen in the water. Decomposition of aquatic vegetation results in an increased consumption of oxygen among decomposers. This results in a decreased amount of oxygen in the water which creates stress among the organisms living in it. Agricultural activities can result in increased amounts of organic material in the streams and thereby have an enrichment effect. This parameter was graded by visually estimating the colour of the water and the amount of algae on stones and other material covered by the water. Pictures from all of the sites along one river were compared to give a relative score. The left picture in Figure 28 is from the site most upstream, C6, in Cumbaza and shows stones that lack algal growth whereas the right picture is from the site downstream Tarapoto, C1, in Cumbaza and shows massive algal growth.
